Contract #: 04-0120F4Cty: SF/ALA Rte: 80 PM: 13.2/13.9File #: 74.28**WELDING INSPECTION REPORT****Resident Engineer:** Pursell, Gary**Address:** 333 Burma Road**City:** Oakland, CA 94607**Report No:** WIR-012774**Date Inspected:** 17-Mar-2010**Project Name:** SAS Superstructure**OSM Arrival Time:** 750**Prime Contractor:** American Bridge/Fluor Enterprises, a JV**OSM Departure Time:** 1750**Contractor:** Goodwin Steel, UK**Location:** Trentham, UK

WELDING INSPECTION REPORT

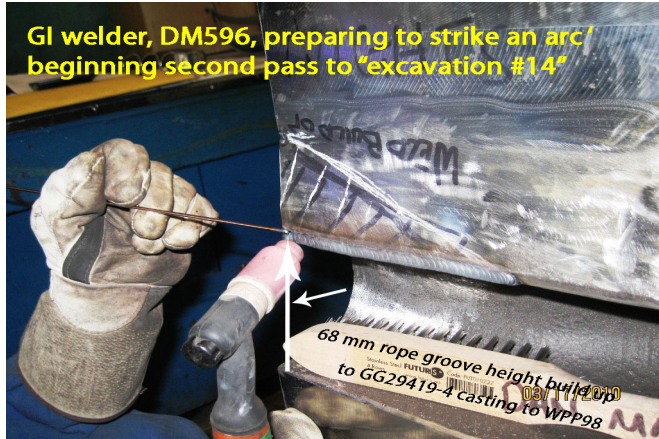
GG29419-4 (B2-1-F) Observed welder D.McDonagh, welder ID DM596, performing Gas Tungsten Arc Welding (GTAW) process using 2.4 mm diameter filler material ER70S-A1 (.5% Mo), 3.2mm ceriated tungsten electrode in a 2G position. Shielding gas in use was 99.9 % pure Argon, at a flow rate of 12 liters a minute. Parameters of WPS 271 Rev 1 (casting repair cycle is classified as a Minor), were verified and followed; actual Amps during observation was 160, voltage 15.6. Temperature of casting was room temperature, 30°C (above 5°C minimum) interpass was below 235°C, confirmed with a temperature melting stick labeled 199C. "Excavation" in work were identified as #14, per the Weld Excavation Map. Observed travel speed and Heat input was 139 mm/min and 1.08 kj/min respectively.
